Sippewissett Association

Newsletter

Tide and Management

at Woodneck Beach

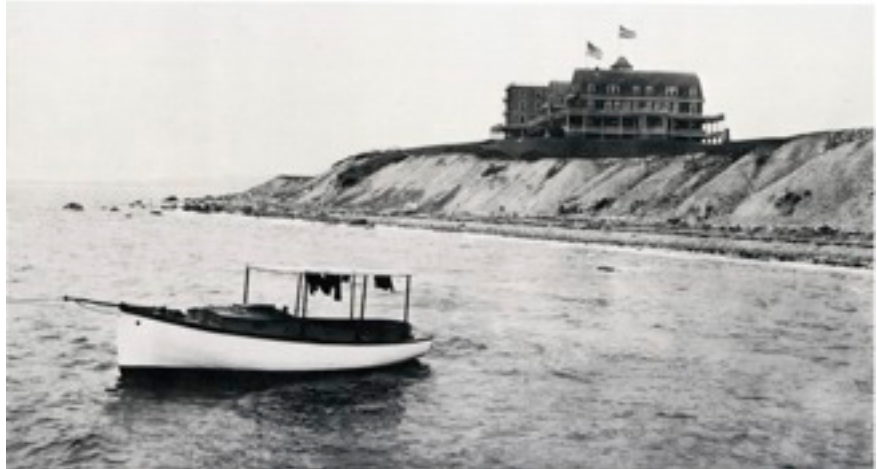
Cape Codder bluff, c. 1890. (from The Book of Falmouth)

Two photos tell the story. The first is of the Cape Codder bluff, circa 1890. We see a natural coastal bluff of sand and gravel, the kind of bluff for which Cape Cod is famous. The bluff has a distinctive 34-degree angle to

the water, which indicates a slope that has adjusted to accommodate sediment lost from its base during minor storms. A pebble/cobble beach below indicates that sand lost from the bluff has migrated, (mainly) northward to “feed” Woodneck Beach but also southward to feed Gunning Point Pond Beach. In 1890, the Cape Codder bluff was the keystone *Source* of sand that kept these beaches sandy.

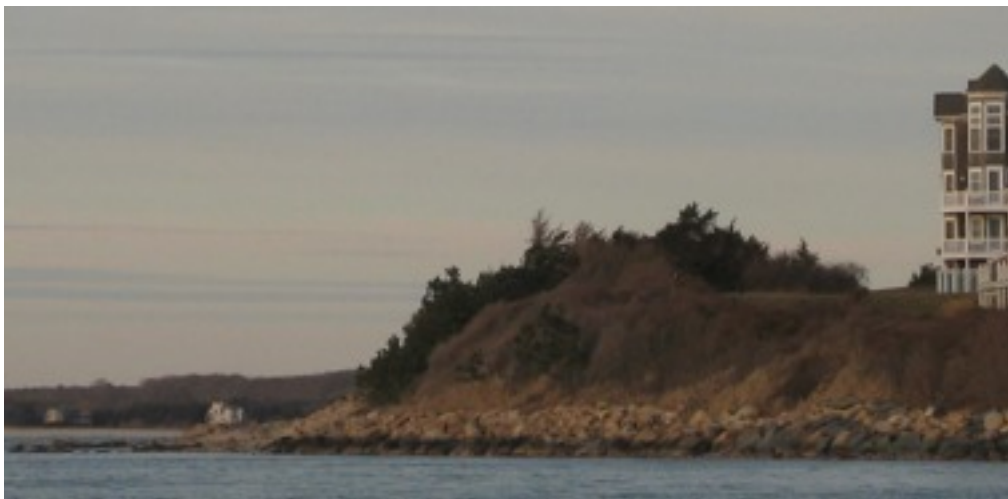
Cape Codder bluff, today (photo by M. Conte).

The rest of the story is told by a photo of this same bluff taken in February 2013. A long continuous wall of rip-rap armors a bluff of much steeper angle, effectively sealing it off from Buzzards Bay. This “Great Wall of Sippewissett” has reduced the rate of erosion of the Cape Codder bluff, but in doing so it has starved the system of sand, dooming the Woodneck embayment and causing chronic malnutrition of the Gunning Point Pond beach/dune system.
